WEB BASED APPLICATION SPECIFIC INSTALLATION INSTRUCTIONS

Cavity and Pocket Insulation

Insulating the Frame and Sash Pockets

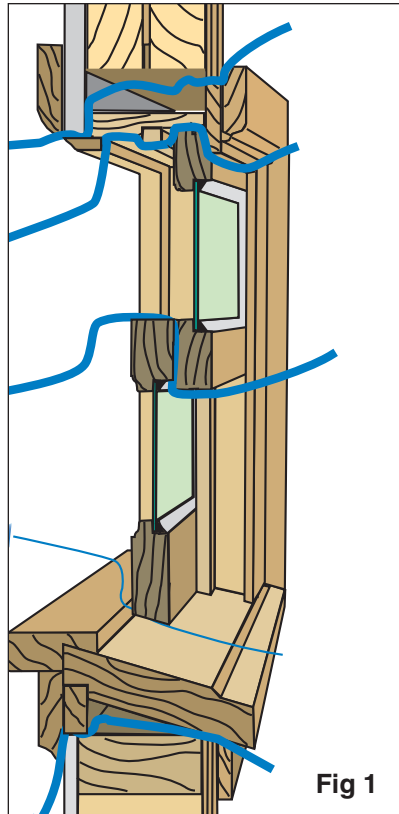
Fig 1

Figure 1:

Most older windows were installed when energy costs were lower and building codes were not so stringent.

Air could come into the home and heat could escape through joints in the window frame and the rough framing and siding and wall board.

Also leaking air and heat are the joints between the sash and the window frame and the interlock of the sash. Even well weatherstripped windows wear out eventually.

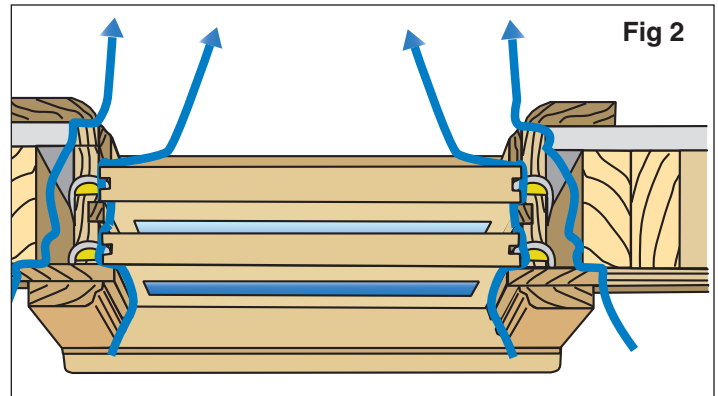
Fig 2

Figure 2:

Adding to the air leak and heat escape is the lack of insulation in the interior pockets. There are pockets of empty space where the old weights and balances were hidden, and between the tapered sill and the flat rough sill, and above the window header — as well as the side jamb cavities.

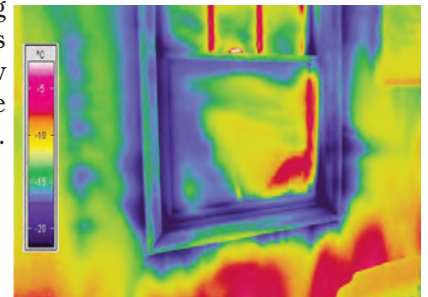
Thermal imaging shows the heat loss through the window and through the frame around the window.

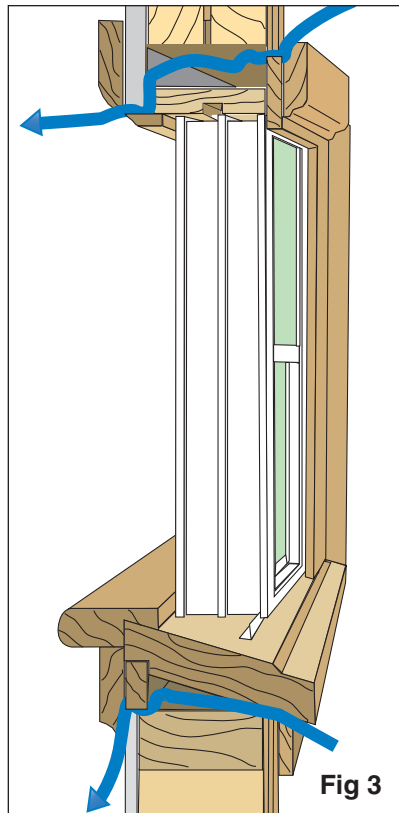
Fig 3

Figure 3:

Modern Replacement Windows have tighter tolerances in the weatherstripping and at the interlocks. This better design and construction cures most of the window caused air and heat transfers because the gaps have been closed.

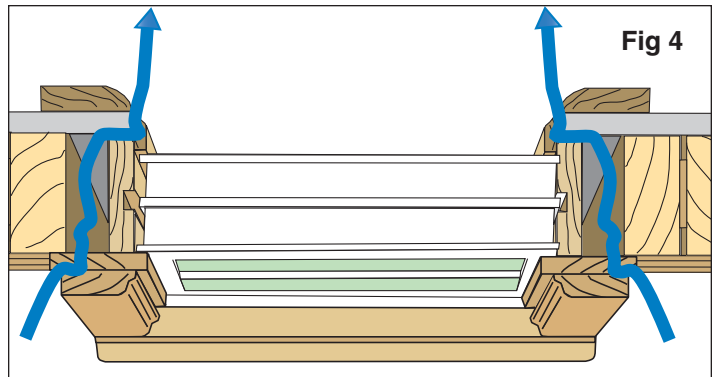
Fig 4

Figure 4:

Too often the new window is fit to the left-in-place old window frame without insulation in the weight/balance pockets, below the sill and above the header - or in the jamb cavities. This leaves significant drafts, heat loss and dissatisfaction with the performance of the new windows. Thermal images show the cold around the new window even though the window itself is “warmer”.

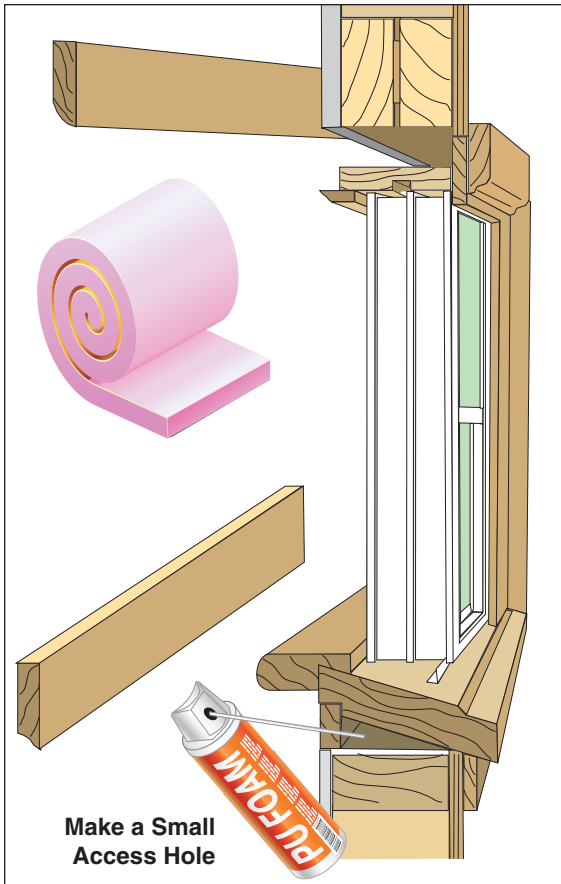
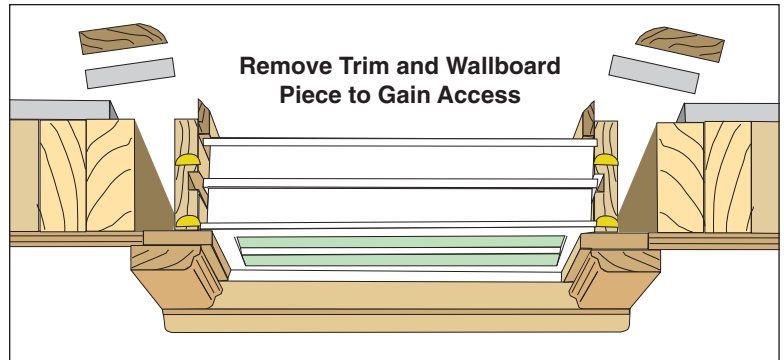
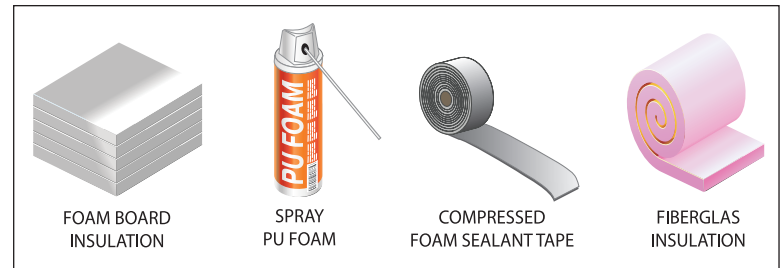
Insulate the Cavities

There are a number of choices to insulate inside the cavities between the old window frame and the rough framing.

Spray PU Foam is the easiest because it doesn't require full removal of the trim if the nozzle can be inserted into the gap.

However, Spray PU Foam expands and you must be careful not to have it expand to where it deforms the window and wall parts.

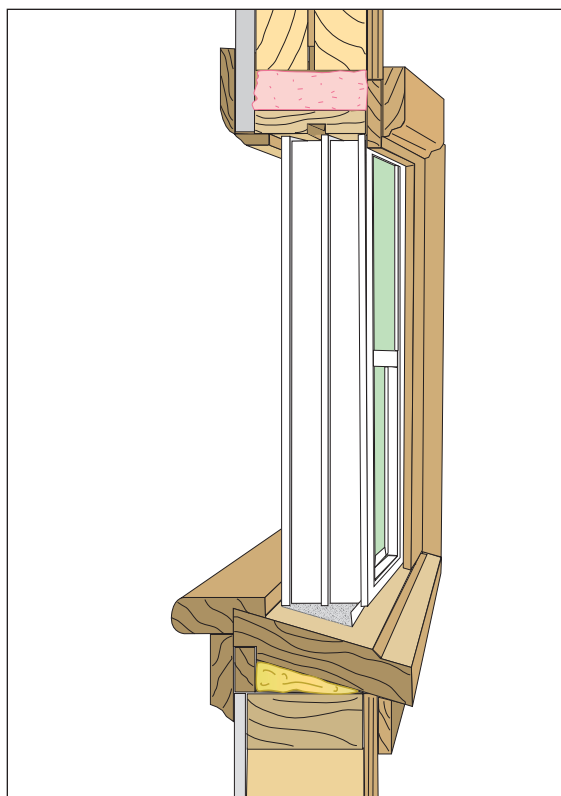
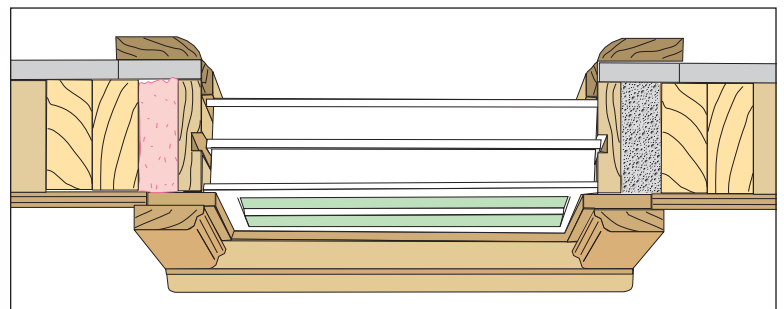
Foam board needs to be cut precisely, while fiberglass batts can be inserted more easily.

Compressed foam conforms to the contours between the rough opening and the new window, best.

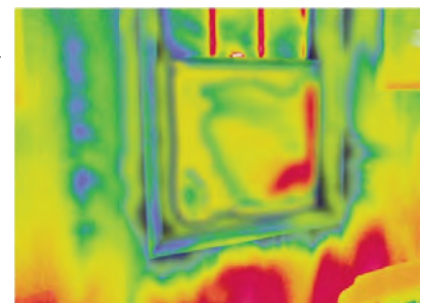
Thermal Images of fully insulated gaps, using any of a variety of material choices, demonstrate that the total opening will block air infiltration and heat loss as well as the new window.
